Home Inspection Report

3287 Leslie

Detroit, MI

Inspected On Mon, Apr 15, 2024 at 12:26 PM

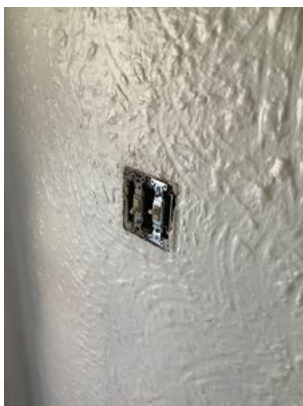
Living Room: Electrical

At the time of the inspection, there was no cover on the electrical switches in the front foyer. Correction recommended.

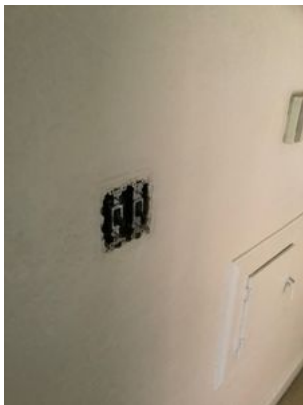
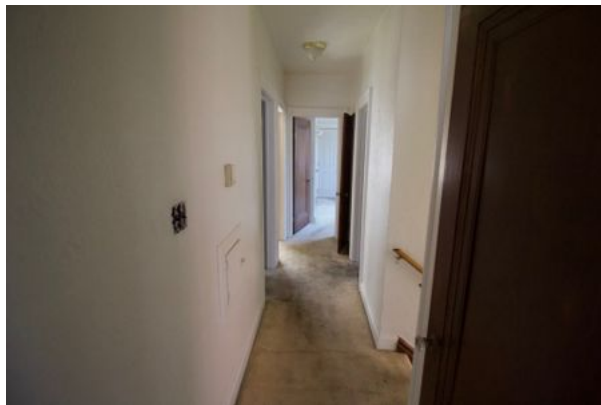
Notes

Upstairs hallway, light switch does not have a cover. They supposed to safety concern. Repair recommended.

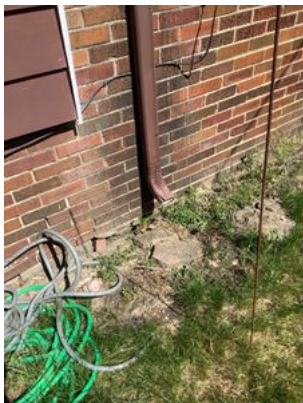
Roofing: Gutters & Downspouts

At the time of the inspection, the back downspout runoff was directly on the foundation. Correction recommended.

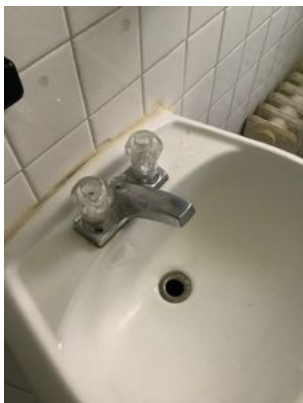
Bathrooms: Bathroom Half Bath: Sink(s)

At the time of the inspection, the water could not be turned on in the bathroom sink. Further evaluation by a competent professional recommended.

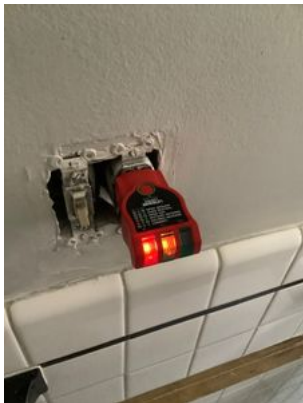
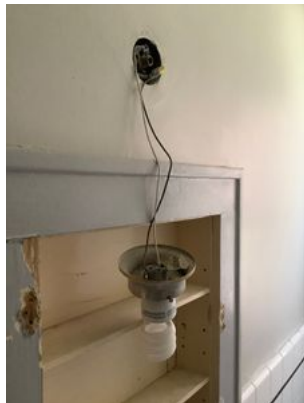
Bathrooms: Bathroom Half Bath: GFCI Protection

At the time of the inspection, the bathroom had no GFCI. The hot and neutral wires were reversed in the electrical outlet. There was also no cover for the electrical socket and the light was not properly attached. Correction recommended.

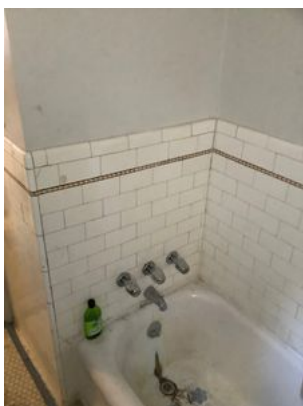
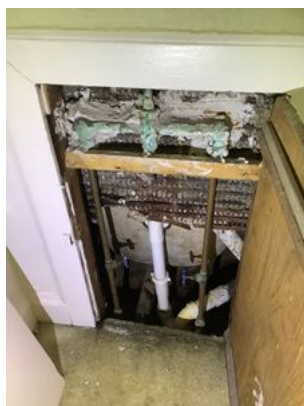
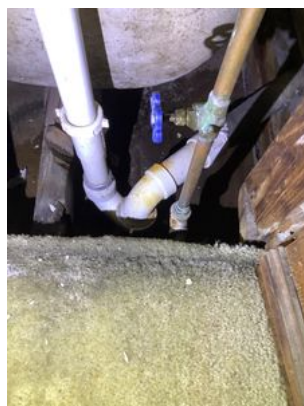
Bathrooms: Bathroom Full Bath: Shower

The diverter is in the state of disrepair. Water is coming from the upstairs bathroom when the shower runs. Correction recommended.

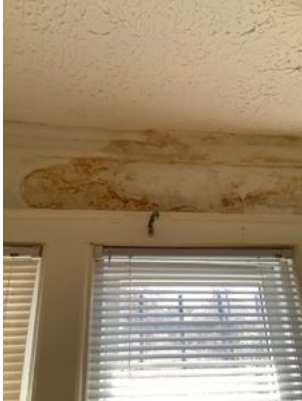
Back Room: Ceiling and Walls

During the time of the inspection, the back room had discoloration in the back wall. This is a sign of leakage in this area. Repair recommended.

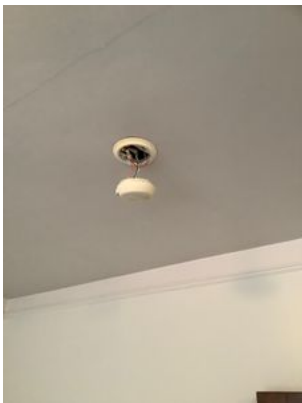
Bedrooms: Bedroom #1: Electrical

At the time of the inspection, the smoke detector was not properly attached. Correction recommended.

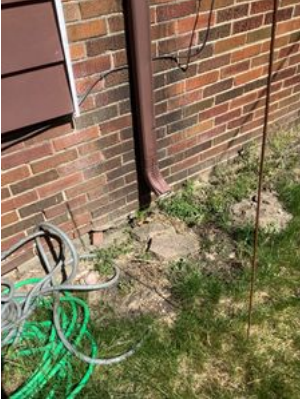
Comment 1

At the time of the inspection, the back downspout runoff was directly on the foundation. Correction recommended.

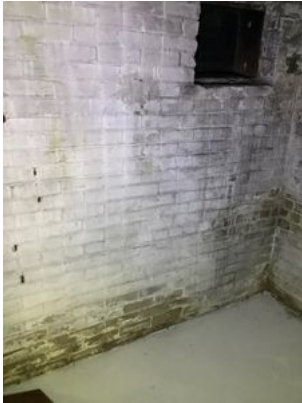
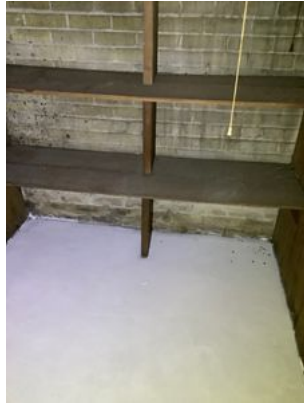
Comment 2

At the time of the inspection, the inspector noticed a paint discoloration about 1 foot from the floor on the walls, consistent in two of the rooms that were not painted. This shows signs of flooding in the past. Recommend monitoring the condition as it might have been corrected.

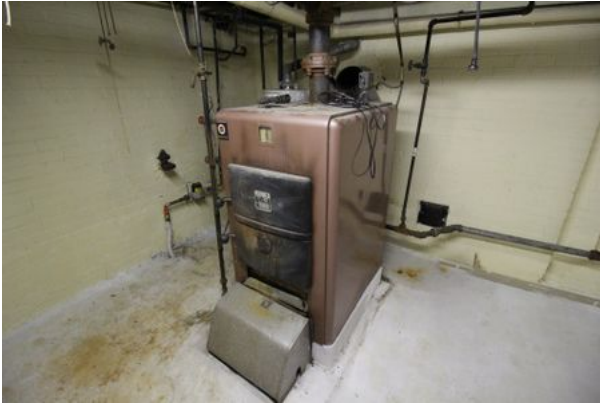
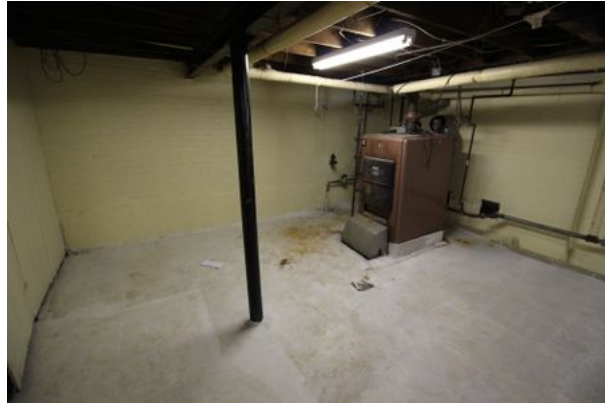
Photo of Furnace Operating

During the inspection the boiler could not be fully inspected. The owner of the property had left the premises by time the inspector got to inspect the boiler. It is advised to ask the owner of the house if the boiler is fully operational.

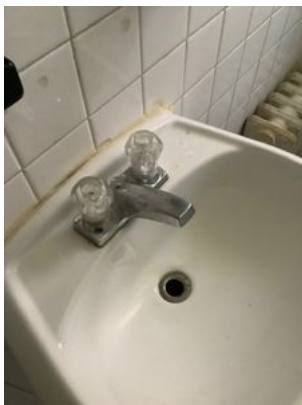
Comment 4

At the time of the inspection, the water could not be turned on in the bathroom sink. Further evaluation by a competent professional recommended.

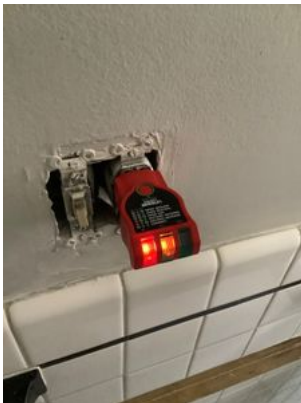
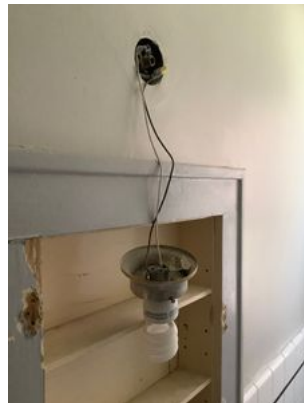
Comment 6

At the time of the inspection, the bathroom had no GFCI. The hot and neutral wires were reversed in the electrical outlet. There was also no cover for the electrical socket and the light was not properly attached. Correction recommended.

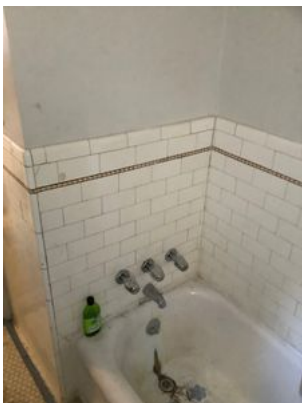
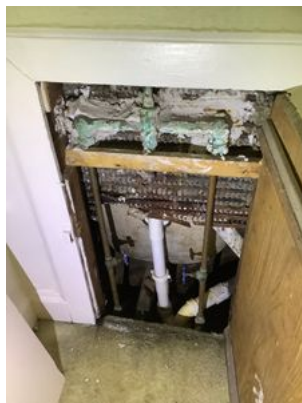
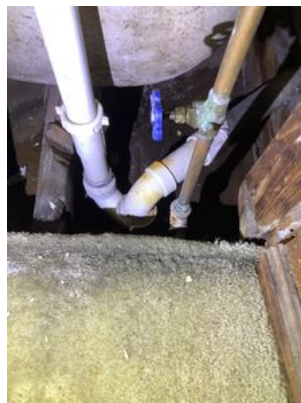
Comment 7

The diverter is in the state of disrepair. Water is coming from the upstairs bathroom when the shower runs. Correction recommended.

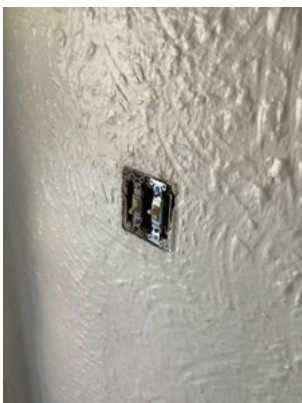
Comment 8

At the time of the inspection, there was no cover on the electrical switches in the front foyer. Correction recommended.

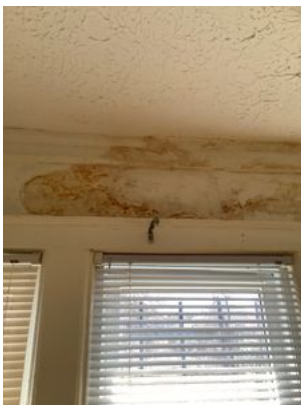
Comment 10

During the time of the inspection, the back room had discoloration in the back wall. This is a sign of leakage in this area. Repair recommended.

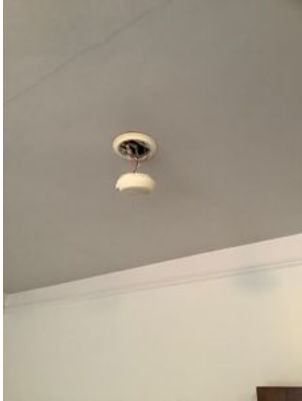
Comment 12

At the time of the inspection, the smoke detector was not properly attached. Correction recommended.

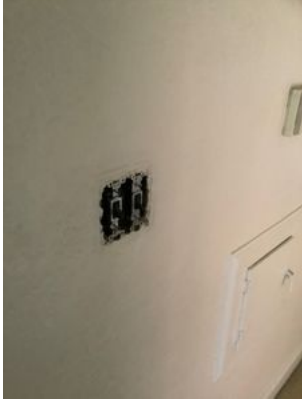
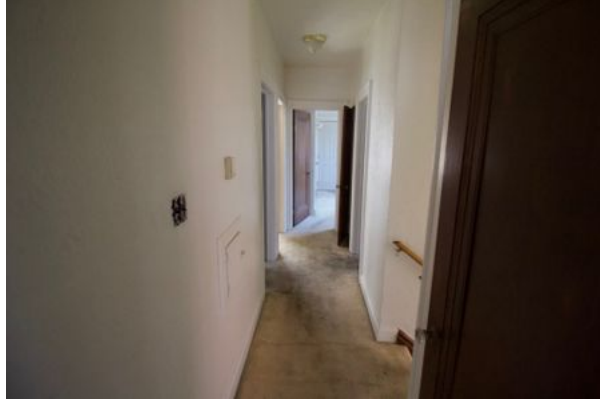
Comment 13

Upstairs hallway, light switch does not have a cover. They supposed to safety concern. Repair recommended.
