Home Inspection Report

2704 Leslie

Inspected By: Samuel Gant

Inspected On Thu, Mar 28, 2024 at 1:13 PM

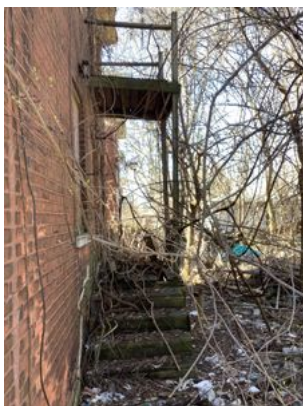
Site: Patios/Decks

Back deck shows severe signs of damage. The inspector reported that it poses a safety concern. Repair recommended.

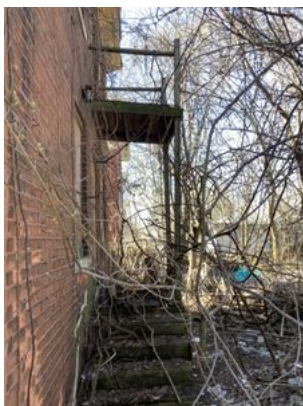
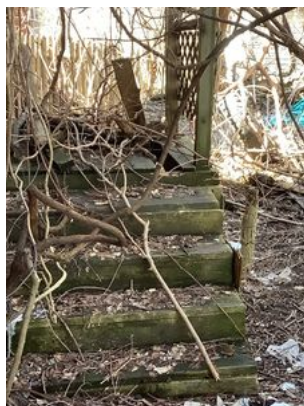
Exterior: Balconies

The inspector observed that the back deck is damaged and missing some railing, and poses a safety concern. Repair recommended.

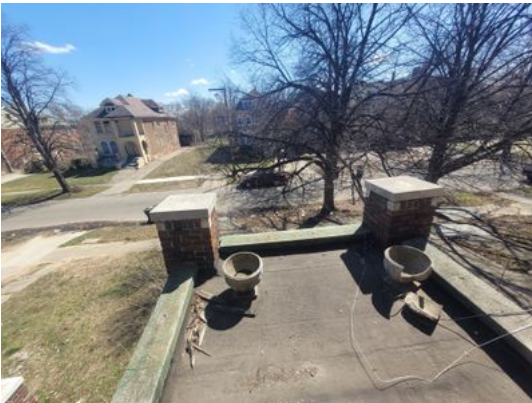
At the time of the inspection, the upstairs balcony did not have any railing. This poses a safety concern. Correction recommended.

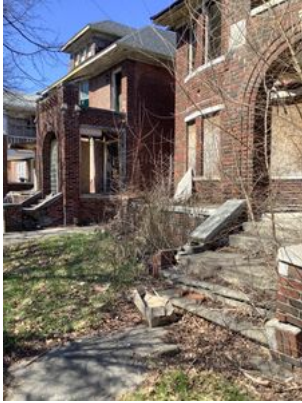
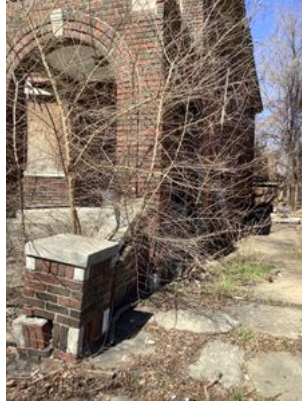
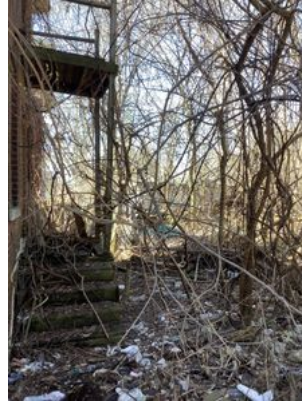
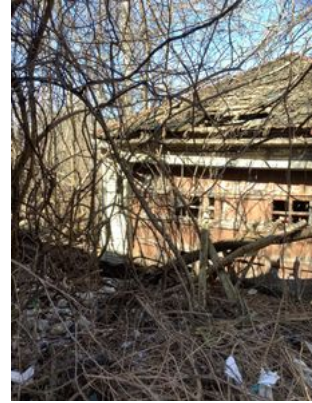
Site: Vegetation

The inspector observed that there was vegetation growing next to structure and foundation. The vegetation has also overgrown severely in the back of the house. Correction, recommend it.

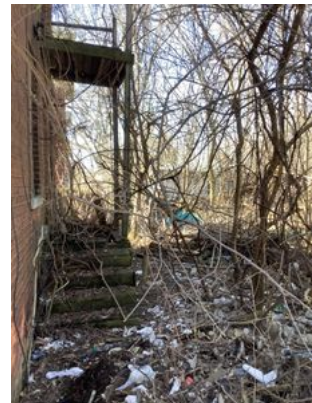
Site: Steps/Stoops

The inspector observed that the porch and the steps showed signs of damage. Repair recommended.

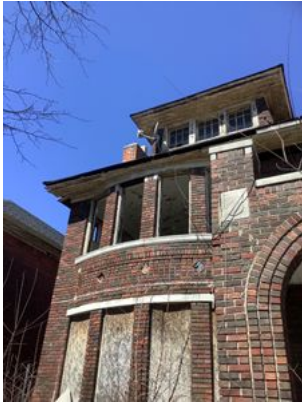
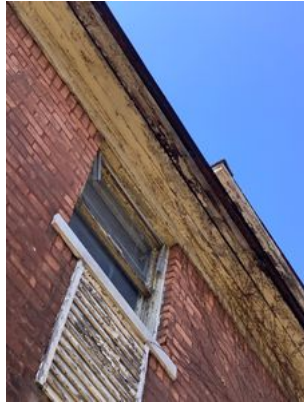
Exterior: Exterior Trim Material

The inspector observed that the trim was damaged or had material. Deep cracks in several places. Repair recommended.

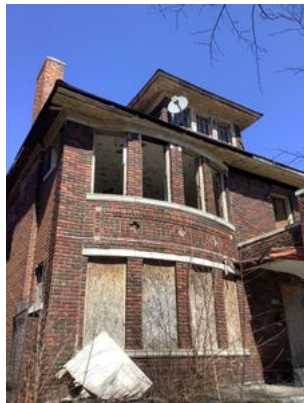
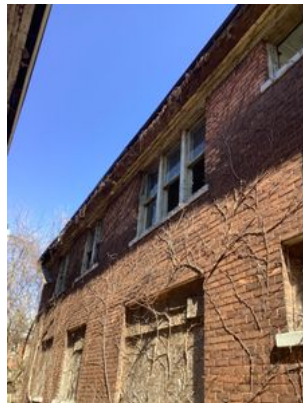
Exterior: Windows

The inspector noticed that several windows head material defects or were not present. Repair recommended.

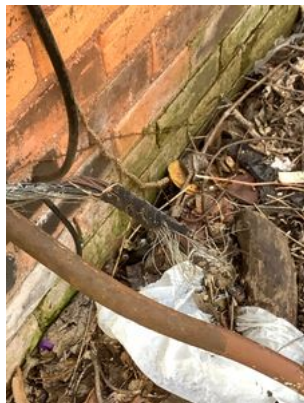
Electrical: Type of Service

The power supply line and the electric meter have been removed from the house and are not present. Correction recommended.

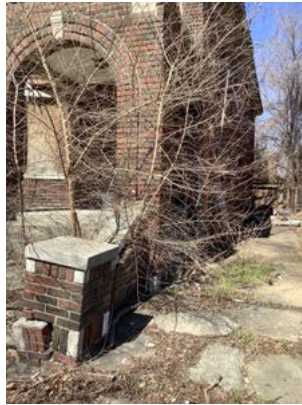
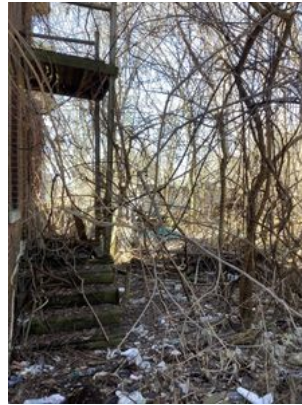
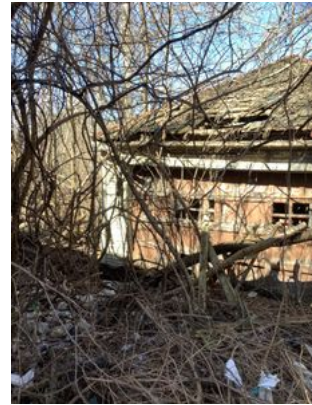
Comment 1

The inspector observed that there was vegetation growing next to structure and foundation. The vegetation has also overgrown severely in the back of the house. Correction, recommend it.

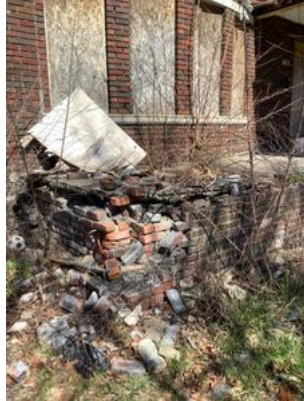
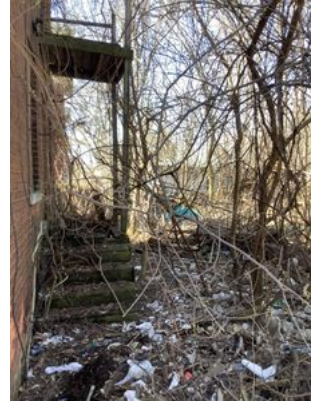
Comment 2

The inspector observed that the porch and the steps showed signs of damage. Repair recommended.

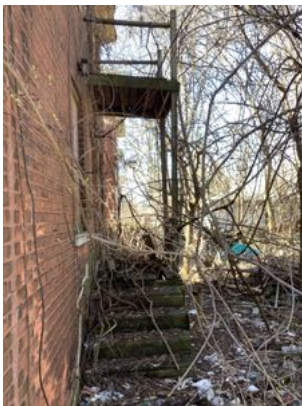
Comment 3

Back deck shows severe signs or damage. The inspector reported that it poses a safety concern. Repair recommended.

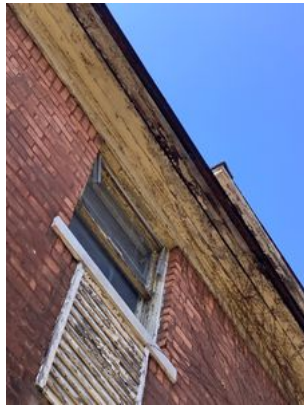
Comment 4

The inspector observed that the trim was damaged or had material. Deep cracks in several places. Repair recommended.

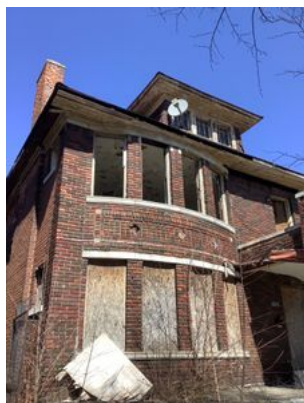
Comment 5

The inspector noticed that several windows head material defects or were not present. Repair recommended.

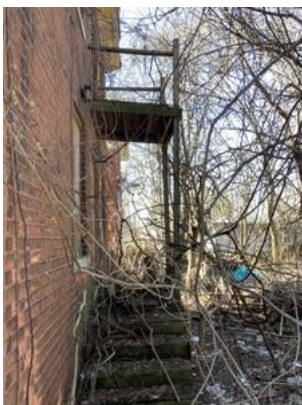
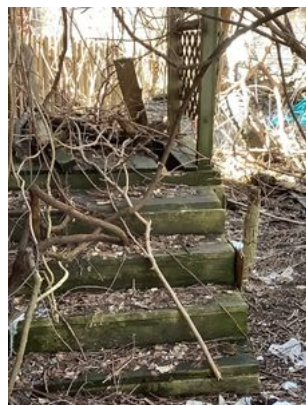
Comment 7

The inspector observed that the back deck is damaged is missing some railing, and poses a safety concern. Repair recommended.

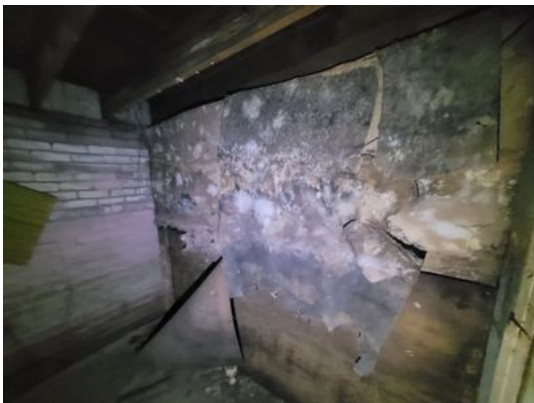
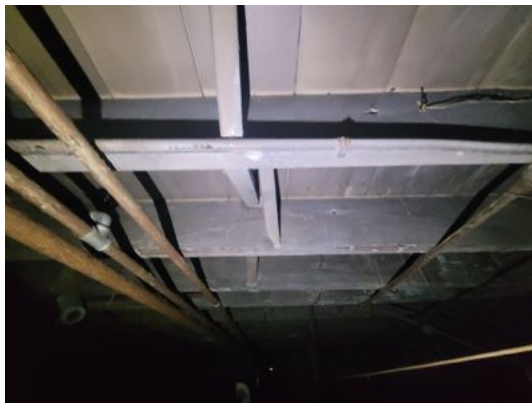
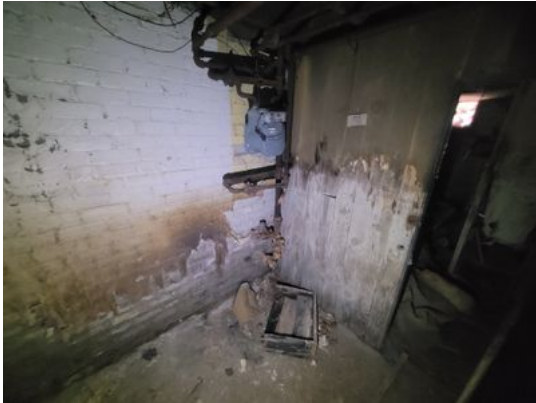
Comment 12

Basement had signs of previous flooding and mildew. Further evaluation by a qualified professional recommended.

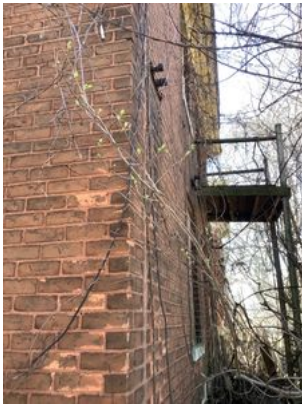
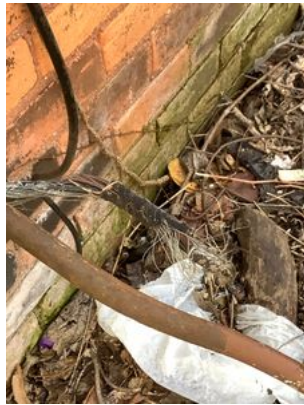
Comment 13

The power supply line and the electric meter have been removed from the house and are not present. Correction recommended.

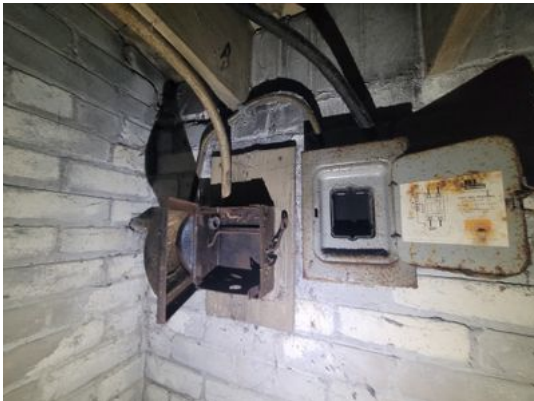
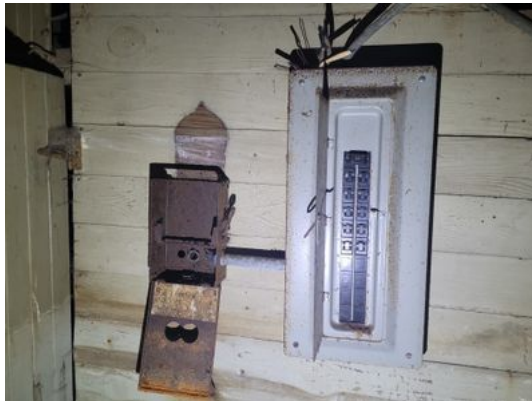
Comment 14

The inspector observed the wiring in the basement has been stripped from the house. The only thing that is, there is the main service panel, the sub panels have all had the wiring taken out of them.

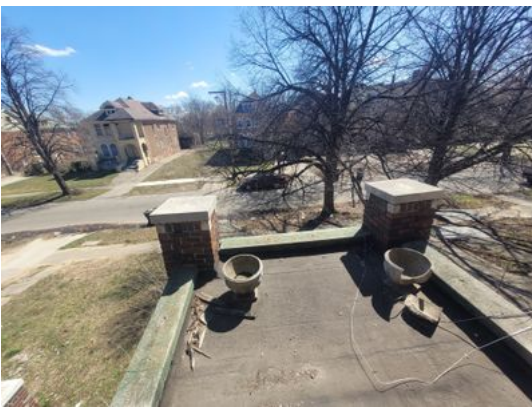
Comment 21

At the time of the inspection, the upstairs balcony did not have any railing. This poses a safety concern. Correction recommended.
