Home Inspection Report

15690 Tacoma
Detroit, MI

Inspected By: Samuel Grant
Inspected On Mon, Oct 2, 2023 at 11:18AM

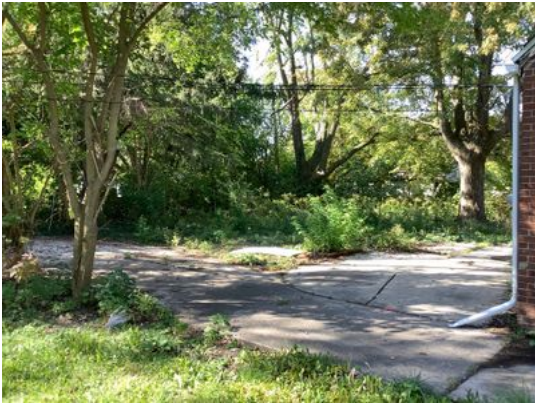
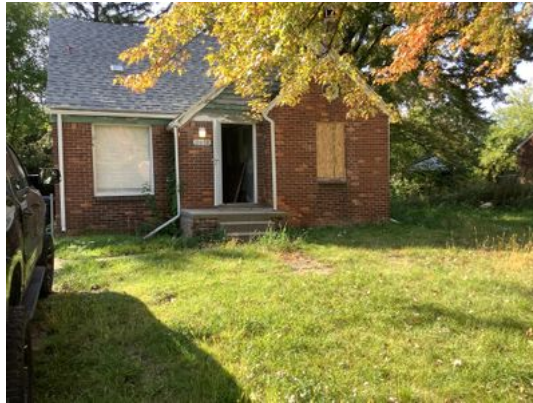
Vegetation

Generally Overgrown, Generally Maintained

Condition: Repair or Replace

Back vegetation overgrown

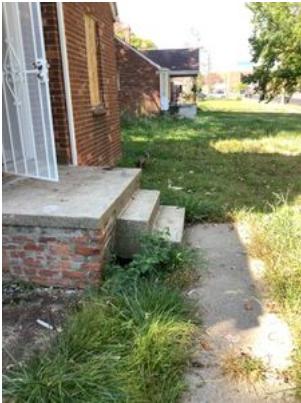
Steps/Stoops

Concrete

Condition: Marginal

Handrail may be needed for safety. Please refer to a building professional for further recommendations.

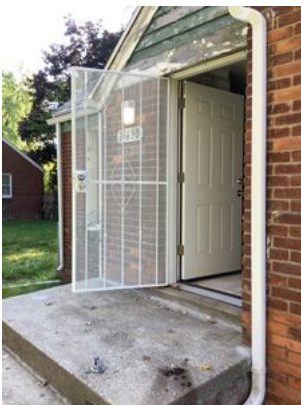
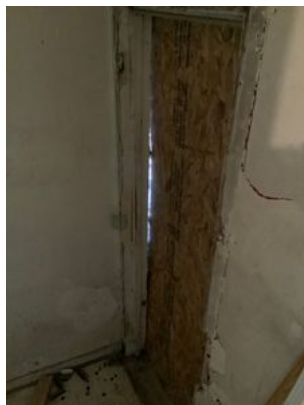
Entry Doors

Condition: Repair or Replace

One exterior door missing

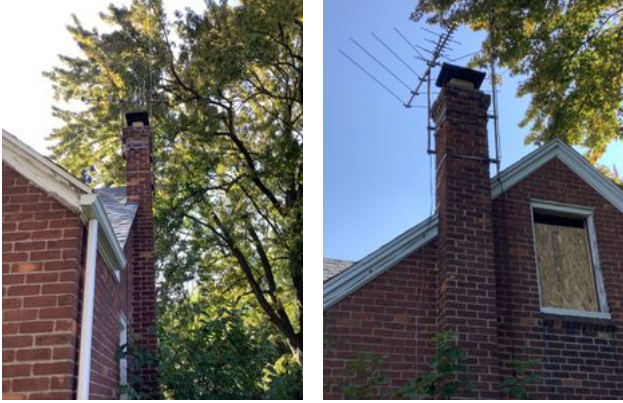
Chimney

Condition: Further Evaluation Required

Small Cracks in chimney, top point may be required. Please refer to a builder for for the recommendation.

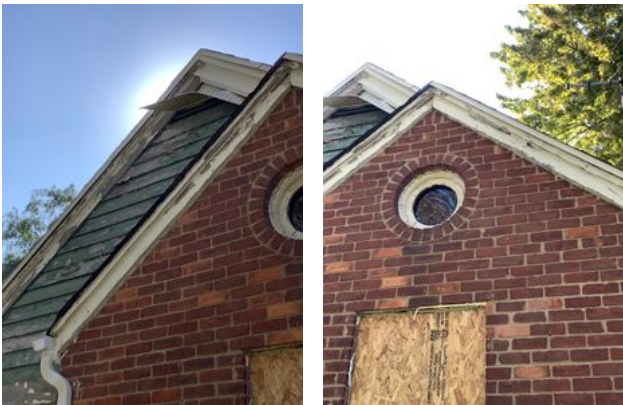
Flashings

Condition: Repair or Replace

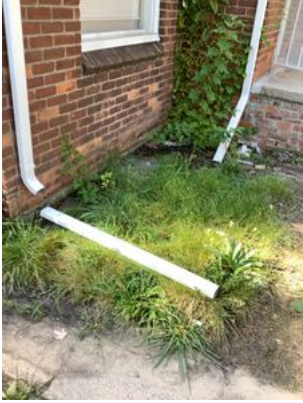
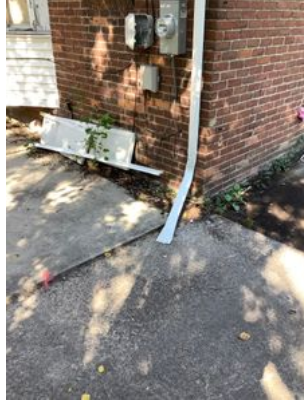
Gutters & Downspouts

Condition: Repair or Replace

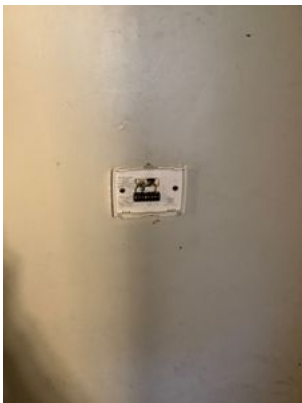
Photo of Thermostat

Condition: Repair or Replace

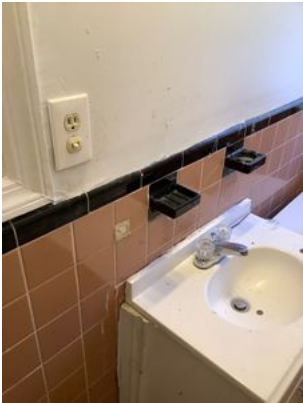
GFCI Protection

Condition: Repair or Replace

Recommend replacing the regular outlet with GFI outlet for safety.

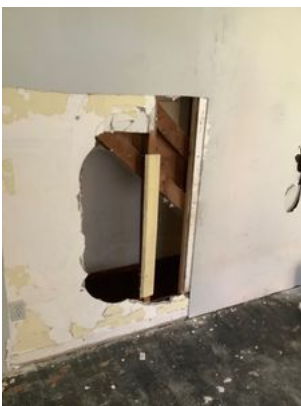
Ceiling and Walls

Condition: Repair or Replace

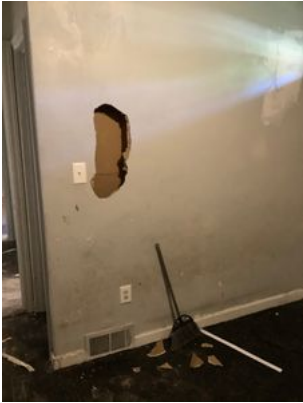
Ceiling & Walls

Condition: Repair or Replace

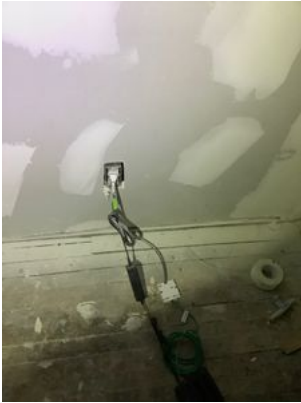
Electrical

Condition: Repair or Replace

Open electrical socket

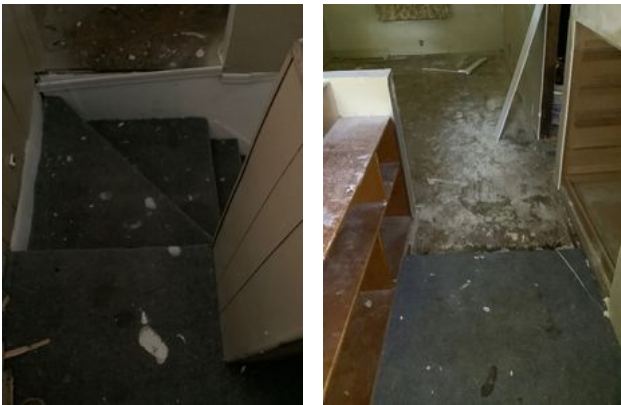
Flooring

Condition: Repair or Replace

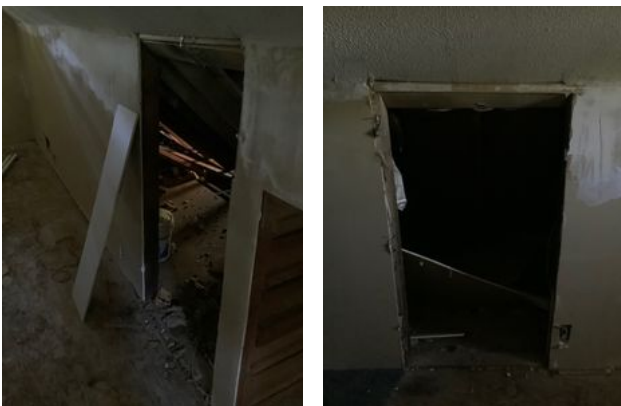
Ceiling & Walls

Condition: Repair or Replace
