## Home Inspection Report

8460 Studebaker  
Detroit, MI 48089

Inspected By: Samuel Gant  
Inspected On Sat, Apr 13, 2024 at 11:14 AM

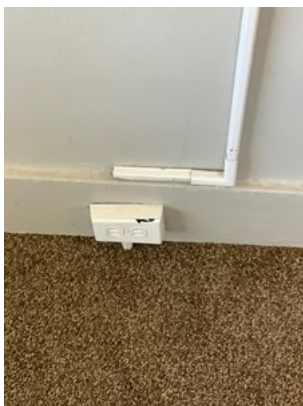
#### Bedrooms: Bedroom #1: Electrical

At the time of the inspection there was a cracked

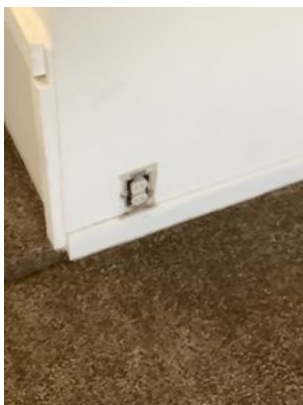
#### Bedrooms: Bedroom #3: Electrical

Inspector observed an outlet without a cover. This poses as a safety concern. Immediate correction recommended

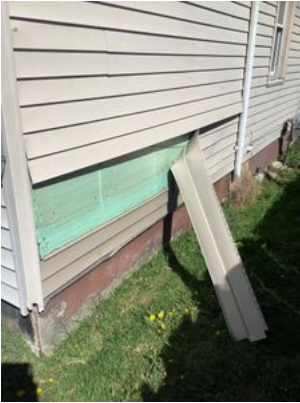
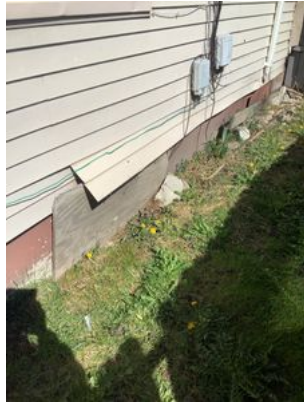
#### Exterior: Exterior Covering

At the time of the inspection, the left side of the house exterior siding had a material defect. Repair recommended.

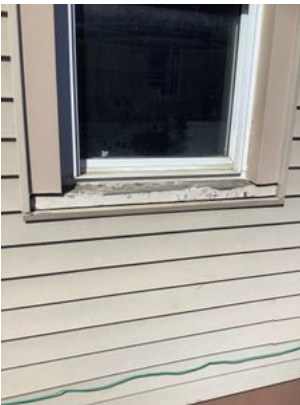
#### Exterior: Exterior Trim Material

At the time of the inspection, a window on the left side of the house was missing lower trim. Correction recommended.

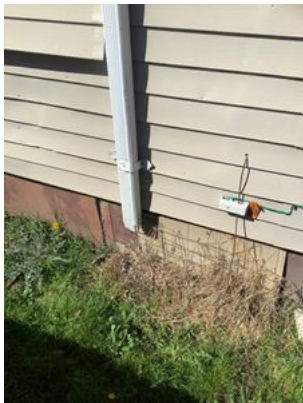
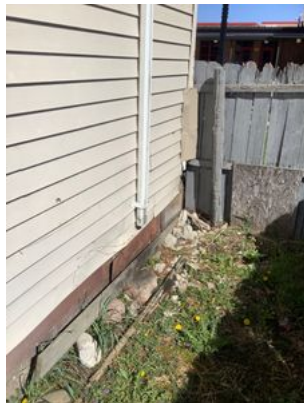
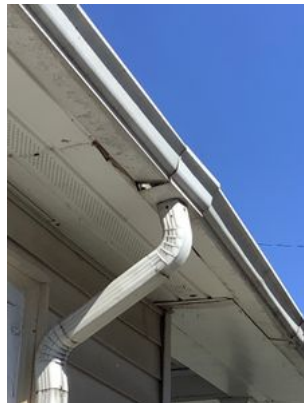
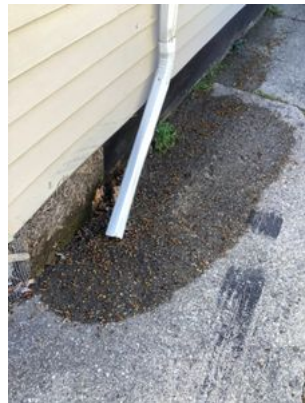
### Roofing: Gutters & Downspouts

At the time of the inspection, there were several downspouts that released water directly on the foundation of the property. It was also observed that some gutters were not correctly attached. Repair recommended.

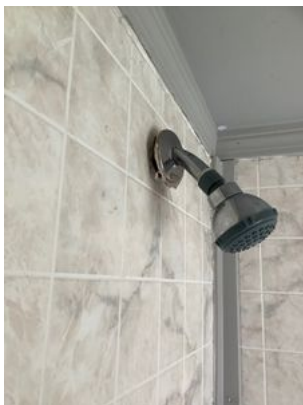
### Bathrooms: Bathroom Full Bath: Shower

It was observed that the shower arm flange was not properly connected to the wall. Correction recommended.

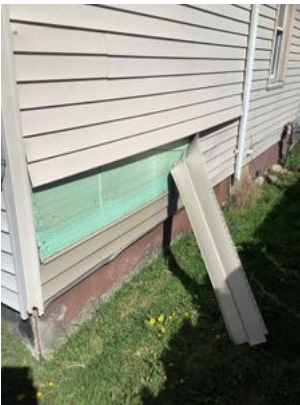
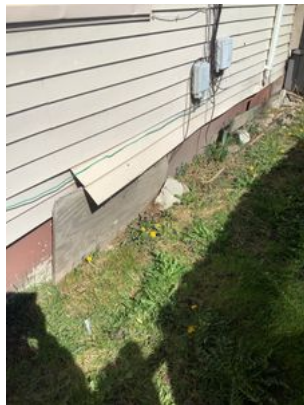
#### Comment 1

At the time of the inspection, the left side of the house exterior siding had a material defect. Repair recommended.

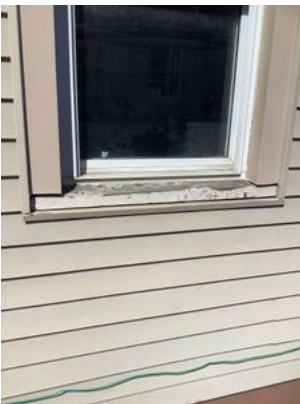
#### Comment 2

At the time of the inspection, a window on the left side of the house was missing lower trim. Correction recommended.

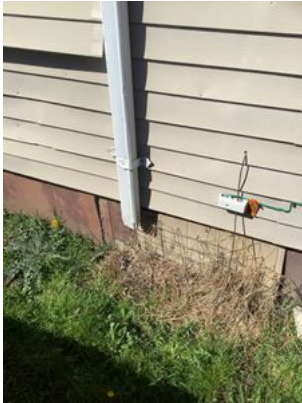
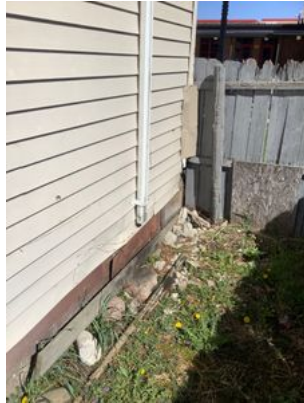
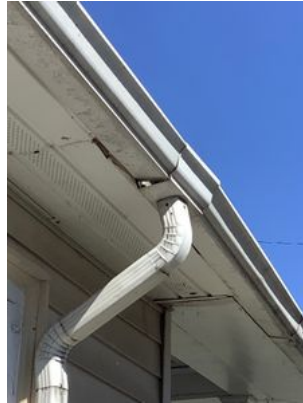
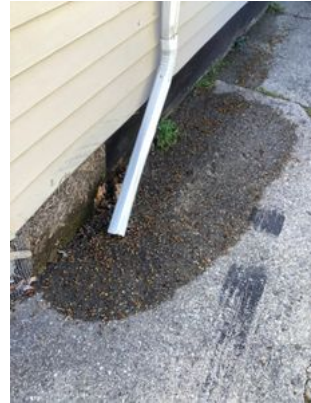
#### Comment 3

At the time of the inspection, there were several downspouts that released water directly on the foundation of the property. It was also observed that some gutters were not correctly attached. Repair recommended.

The inspector observed that the floor in the house showed signs of marginal settling of the foundation and was slightly uneven. It is of the inspectors opinion that this will not post any immediate issue with the ability to inhabit the house but should be monitored. Correction of the downspout runoff to the foundation of the house is recommended and further monitoring of the situation is also recommended.

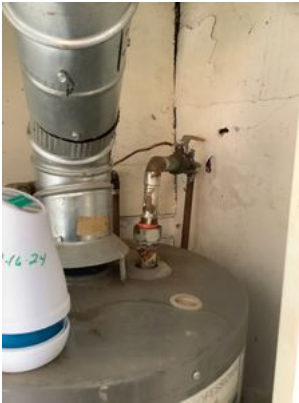
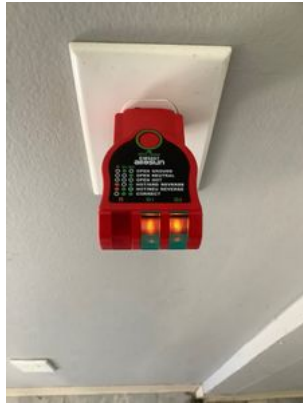
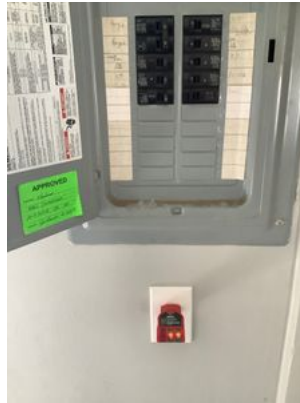
#### Comment 5 Information

During the time of the inspection, it was observed that the ground wire seem to be properly attached to the Water supply line. It is of the inspectors opinion that the house electrical is properly grounded.

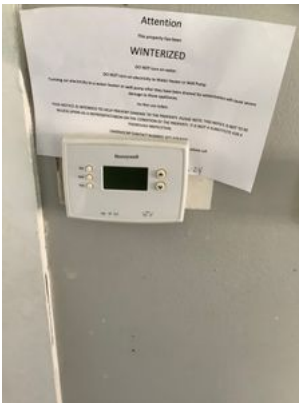
## Photo of Thermostat

During the time of the inspection, the thermostat was not properly inspected because it did not have power. When the inspector attempted to open the thermostat to see if batteries were present the thermostat was not properly attached to the wall. Correction recommended.

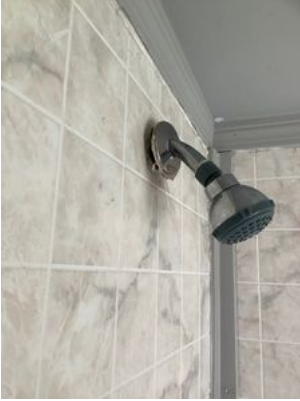
### Comment 9

It was observed that the shower arm flange was not properly connected to the wall. Correction recommended.

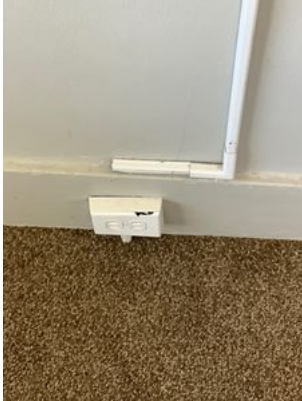
**Comment 10**

At the time of the inspection there was a cracked

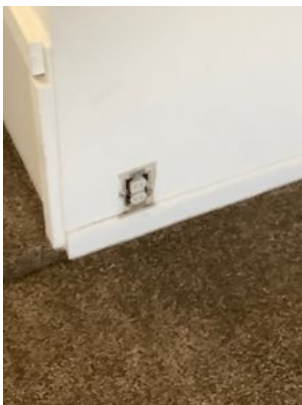
#### Comment 11

Inspector observed an outlet without a cover. This poses as a safety concern. Immediate correction recommended
