Home Inspection Report

3287 Leslie

Detroit, MI

Inspected On Mon, Apr 15, 2024 at 12:26 PM

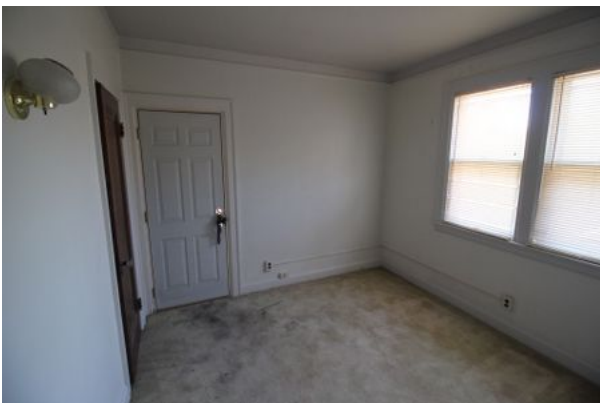
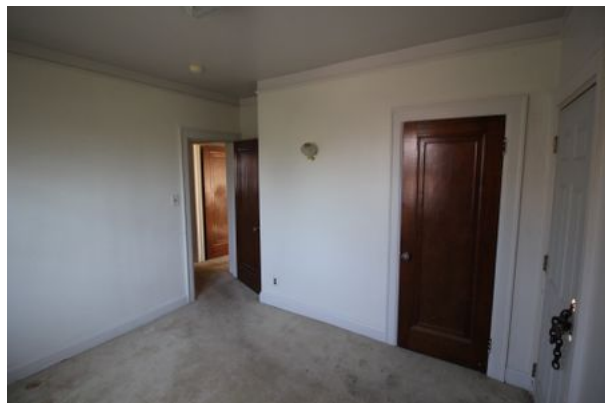
Bedroom #4

Overview Photos of Bedroom

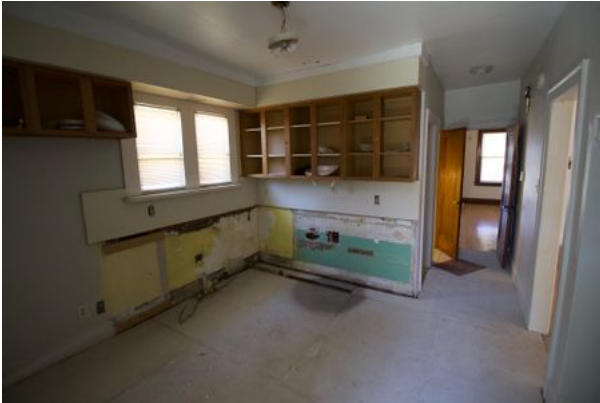
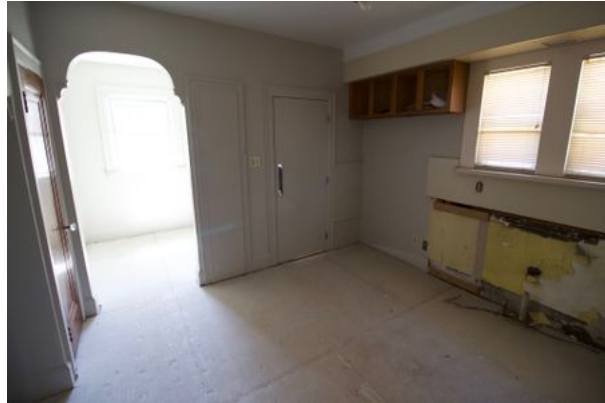
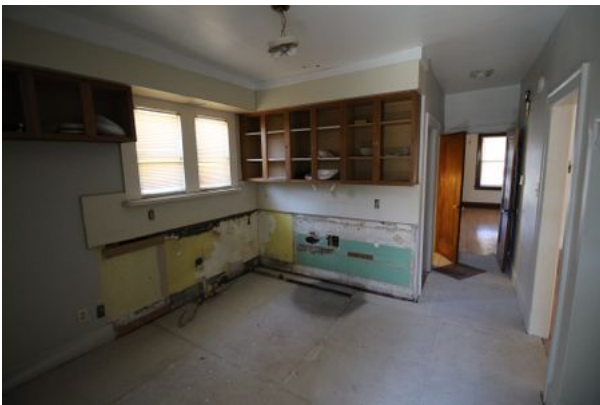
Overview Photo of Kitchen
