Home Inspection Report

2704 Leslie

Inspected By: Samuel Gant

Inspected On Thu, Mar 28, 2024 at 1:13 PM

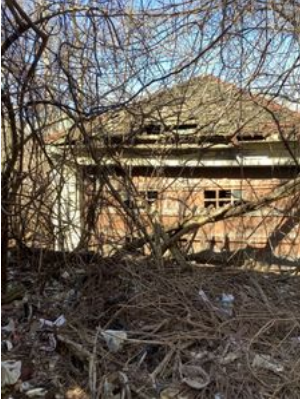
The garage is in a severe state of disrepair. It was of the inspectors opinion that it is deemed to be unsafe. Correction recommended.

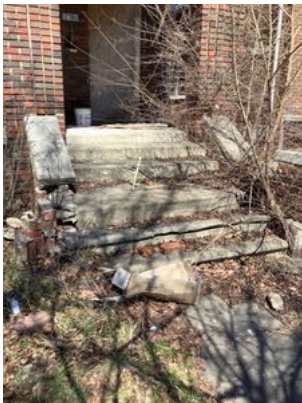
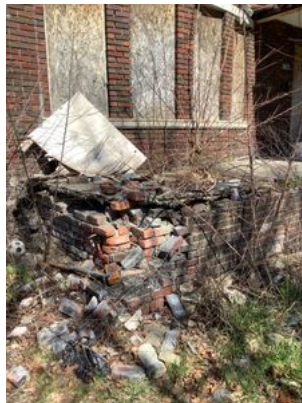
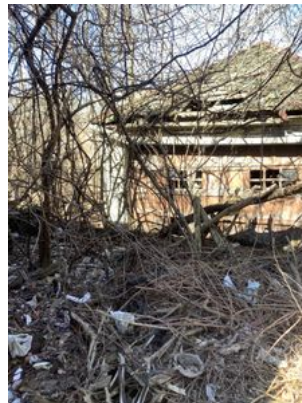
Site: Steps/Stoops

The inspector observed that the porch and the steps showed signs of damage. Repair recommended.

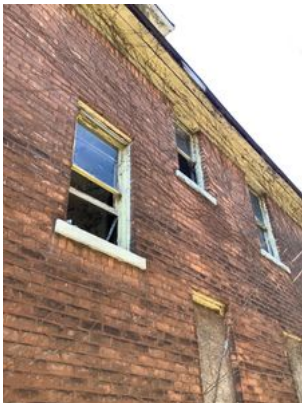
Exterior: Windows

The inspector noticed that several windows head material defects or were not present. Repair recommended.

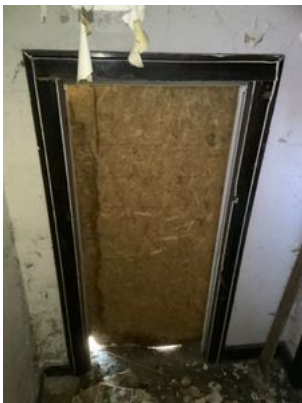
Exterior: Entry Doors

The inspector observed at the front interior door was not present.

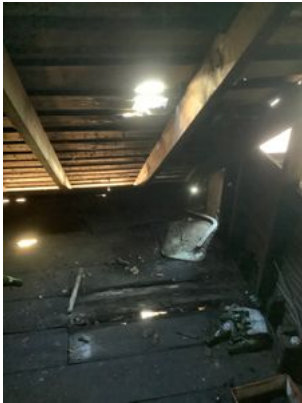
Roofing

The inspector observed that the roof it was missing, and that there was water damage to the floor in the attic as a result. Fan installation on roof recommended.

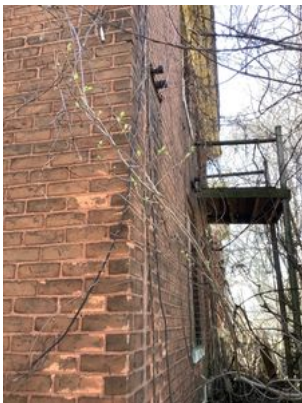
Electrical: Type of Service

The power supply line and the electric meter have been removed from the house and are not present. Correction recommended.

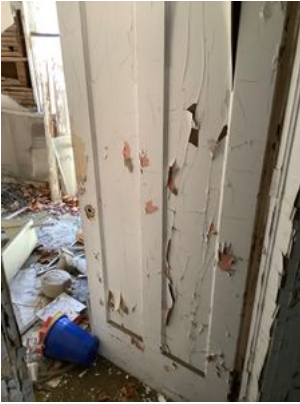
Bedrooms Unit #2: Bedroom #1: Doors

Inspector observed at the door does not open or close. Repair recommended.

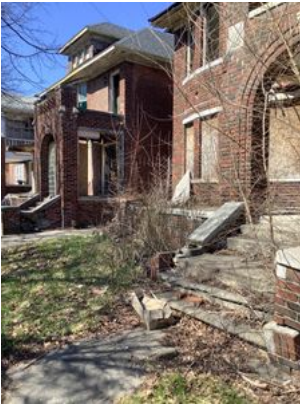
The inspector observed that there was vegetation growing next to structure and foundation. The vegetation has also overgrown severely in the back of the house. Correction, recommend it.

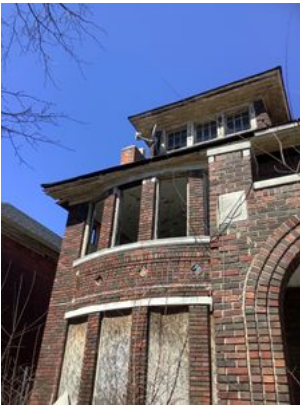
The inspector observed that the trim was damaged or had material. Deep cracks in several places. Repair recommended.

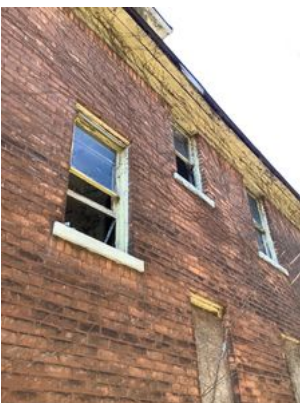
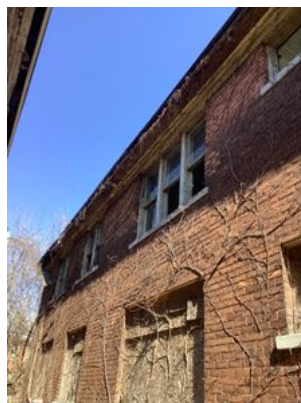
The inspector noticed that several windows head material defects or were not present. Repair recommended.

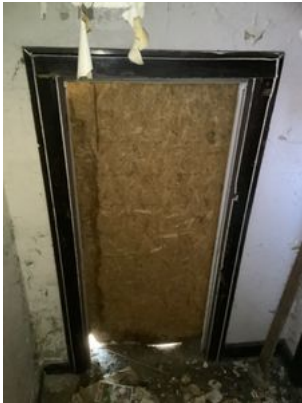
The inspector observed at the front interior door was not present.

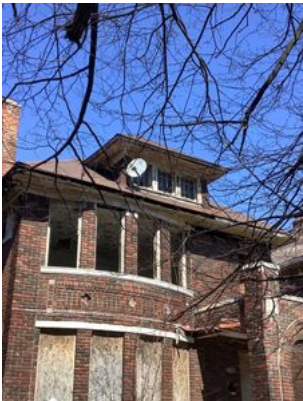
Photo Of Each Roofing Type

After observing the attic interior, it is of the inspectors opinion that the roof is in good condition, except for one area that a vent was missing. Water damage shown on the floor from below the vent.

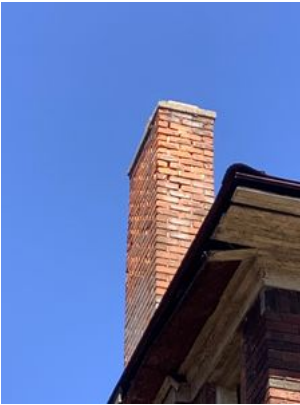
Chimney

The inspector observed that the chimney had wear and tear. Tuckpointing might be required. Further evaluation by a specialist recommended.

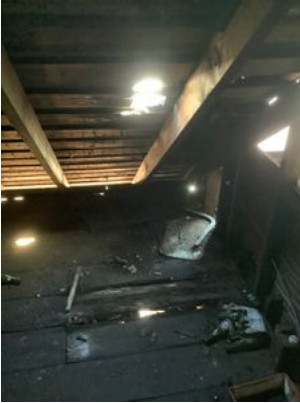
The inspector observed that the roof it was missing, and that there was water damage to the floor in the attic as a result. Fan installation on roof recommended.

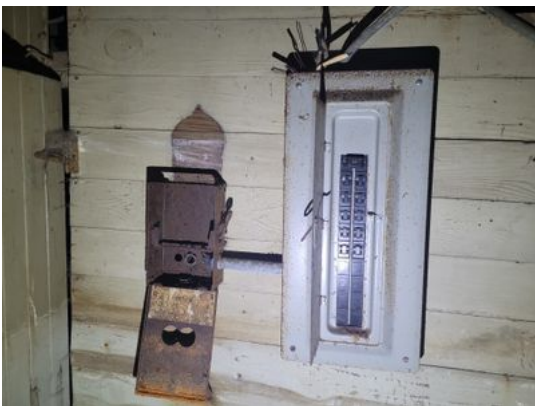
Photo of Panel

Condition: Repair or Replace

The inspector observed the wiring in the basement has been stripped from the house. The only thing that is, there is the main service panel, the sub panels have all had the wiring taken out of them.

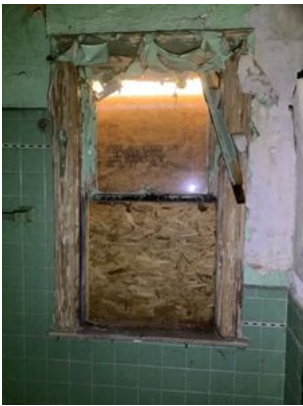
Window

Condition: Repair or Replace

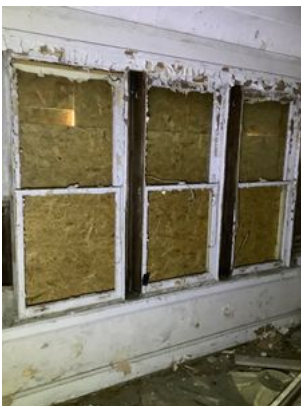
Single Hung, Wood

Condition: Repair or Replace

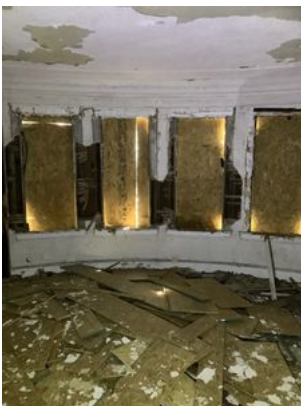
Double Hung

Condition: Repair or Replace

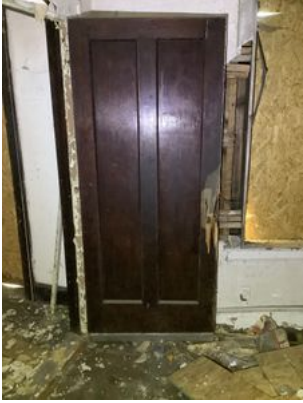
Doors

Condition: Repair or Replace

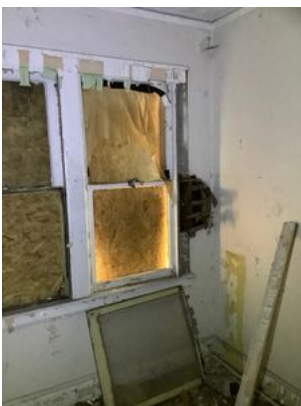
Drywall/Plaster

Condition: Repair or Replace

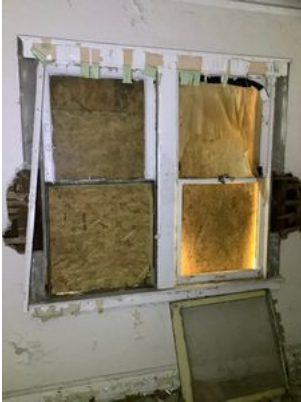
Double Hung

Condition: Repair or Replace

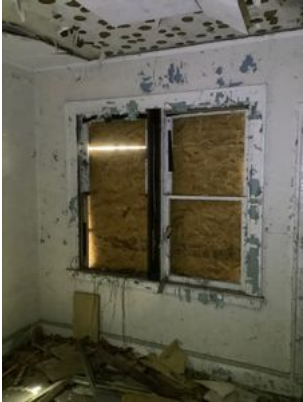
Double Hung

Condition: Repair or Replace

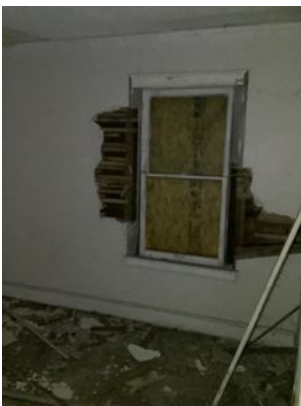
Drywall/Plaster

Condition: Repair or Replace

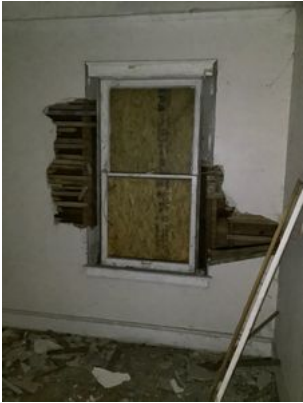
Single Hung

Condition: Repair or Replace

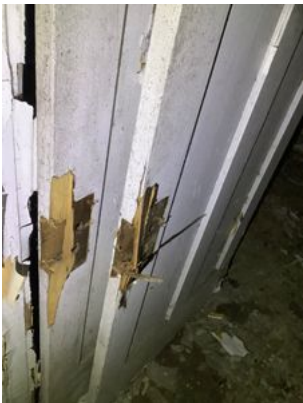
Doors

Condition: Repair or Replace

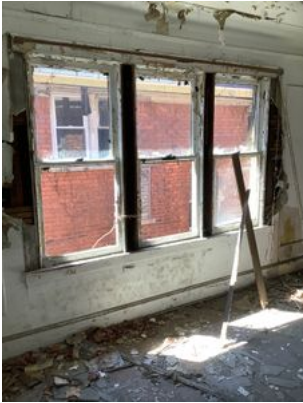
Single Hung

Condition: Repair or Replace

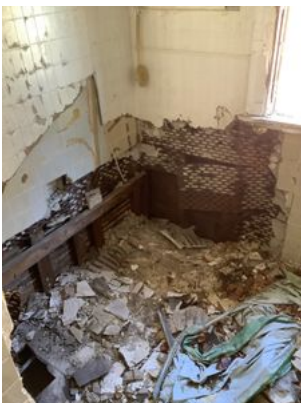
Tile

Condition: Repair or Replace

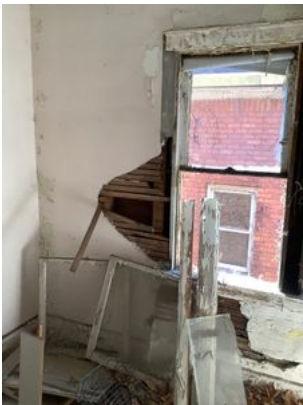
Drywall/Plaster

Condition: Repair or Replace

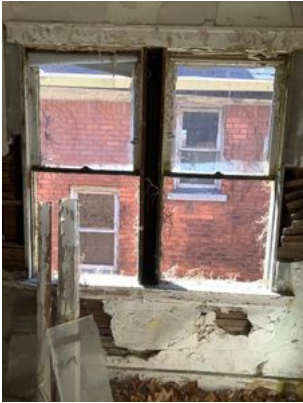
Single Hung

Condition: Repair or Replace

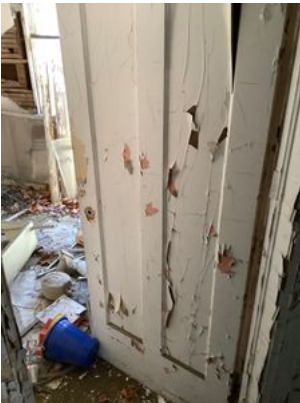
Doors

Condition: Repair or Replace

Repair or Replacement Needed

Inspector observed at the door does not open or close. Repair recommended.

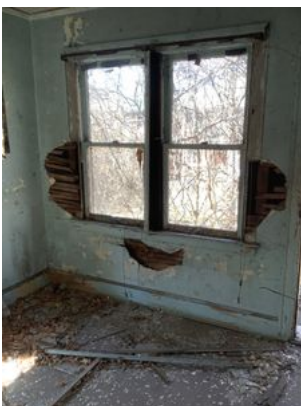
Drywall/Plaster

Condition: Repair or Replace

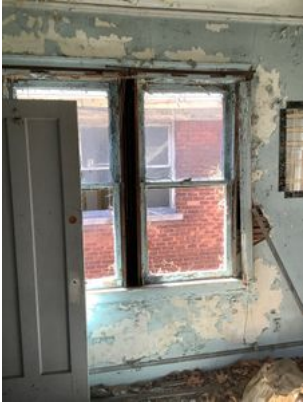
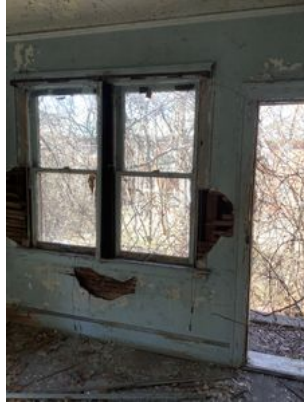
Single Hung

Condition: Repair or Replace

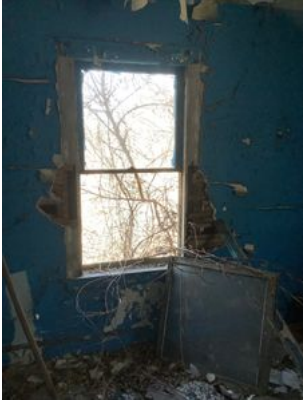
Drywall/Plaster

Condition: Repair or Replace

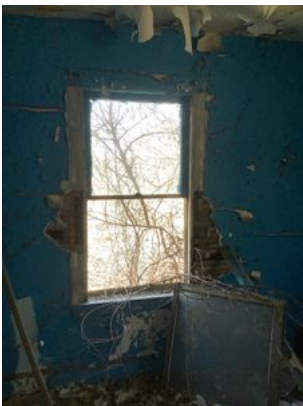
Single Hung

Condition: Repair or Replace

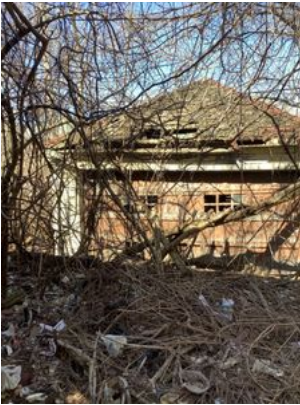
Safety Concern

The garage is in a severe state of disrepair. It was of the inspectors opinion that it is deemed to be unsafe. Correction recommended.
