Home Inspection Report

15690 Tacoma
Detroit, MI

Inspected By: Samuel Grant
Inspected On Mon, Oct 2, 2023 at 11:18AM

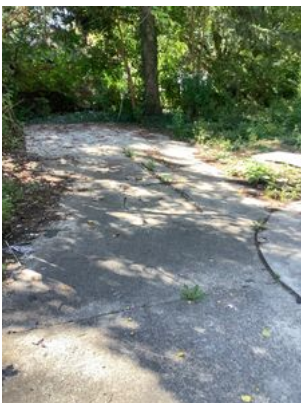
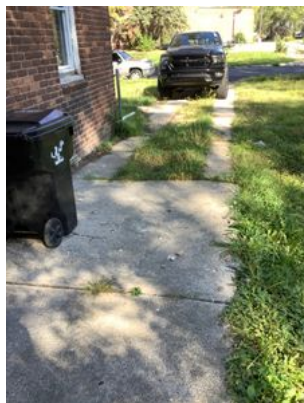
Concrete

Condition: Marginal

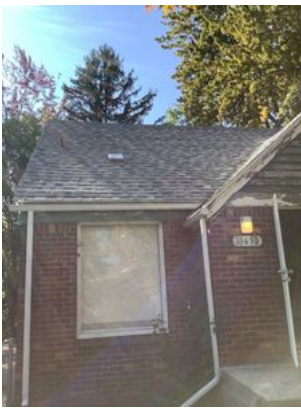
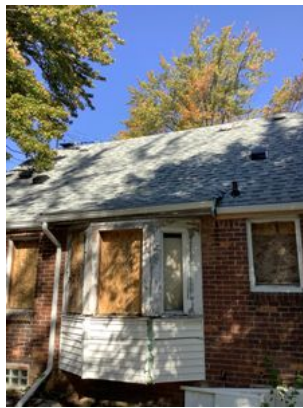
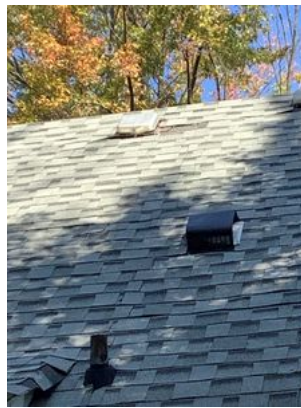
Photo Of Each Roofing Type

3 Tab Shingle

Condition: Marginal

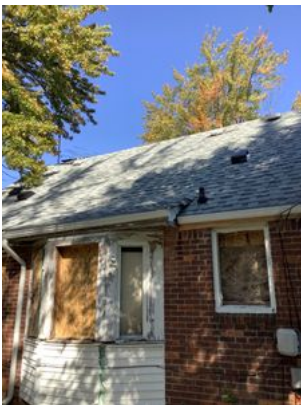
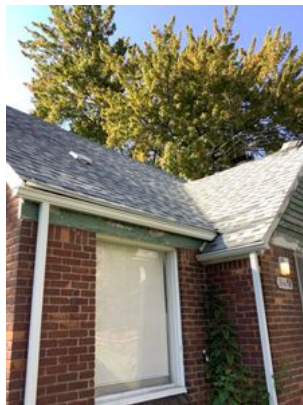
Chimney

Brick

Condition: Further Evaluation Required

Monitor Condition

Small Cracks in chimney, top point may be required. Please refer to a builder for for the recommendation.

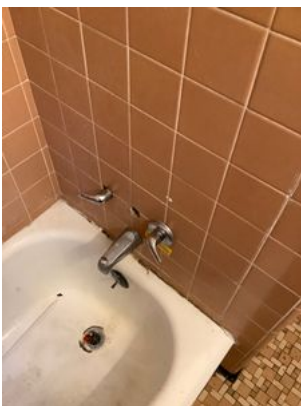
Condition: Marginal

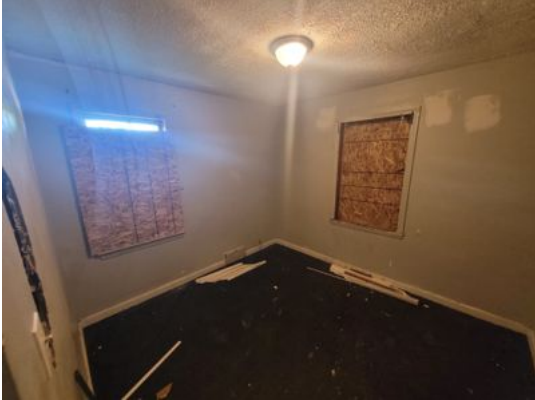
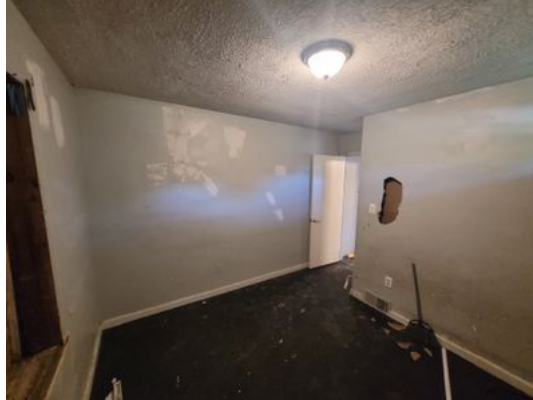
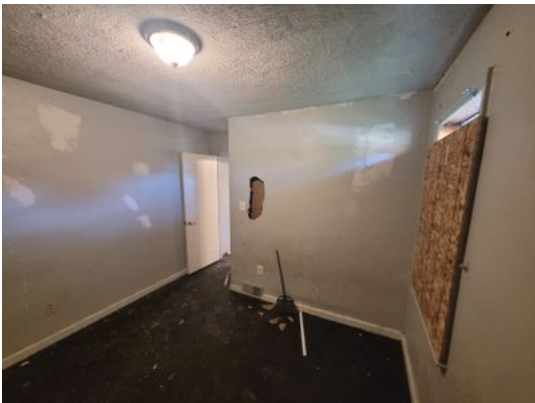
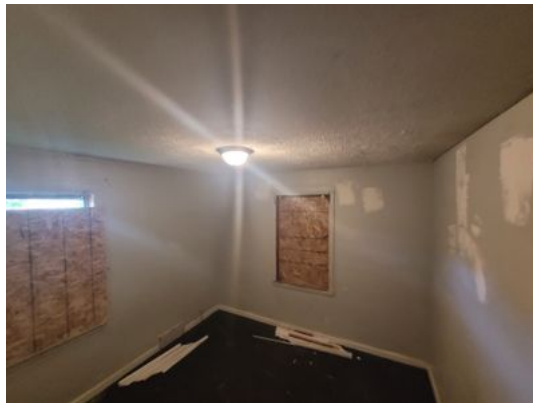
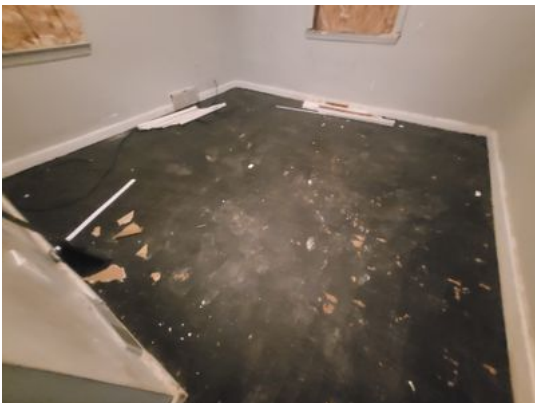
Overview Photos of Bedroom

Windows missing

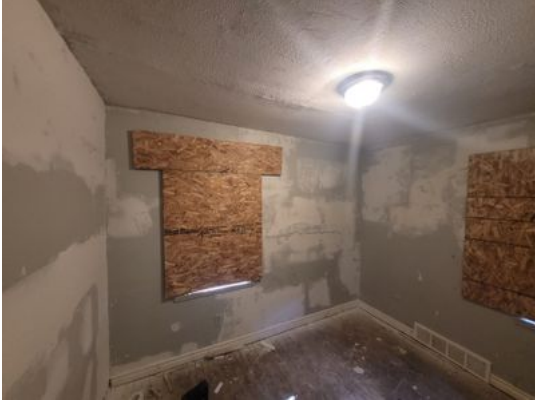
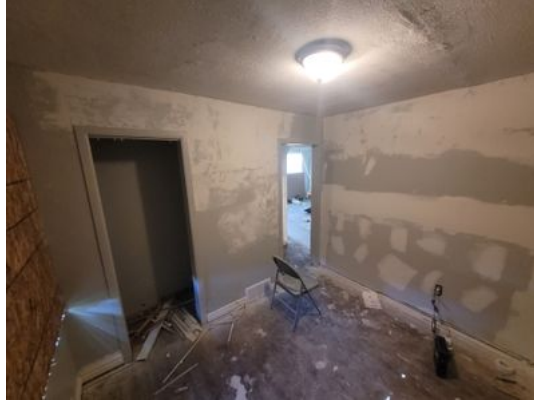
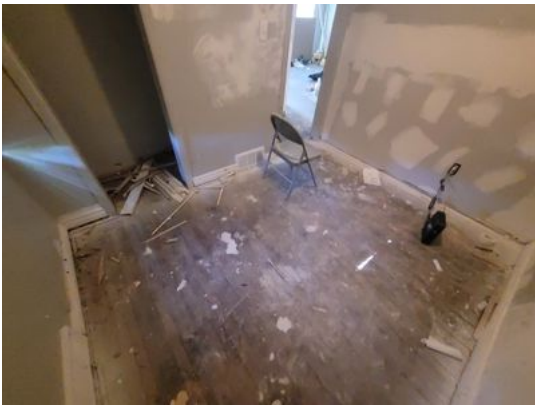
Overview Photos of Bedroom

Windows missing
